MPC7450, MPC7451, MPC7441 Chip Errata

MPC7451
MPC7450
MPC7441

This document details all known silicon errata for the MPC7451, MPC7450, and MPC7441. The MPC7450 has the same functionality as the MPC7451 and MPC7441, and any differences between the other microprocessors are noted in the document. The MPC7451, MPC7450, and MPC7441 are PowerPC™ microprocessors. Table 1 provides a revision history for this chip errata document.

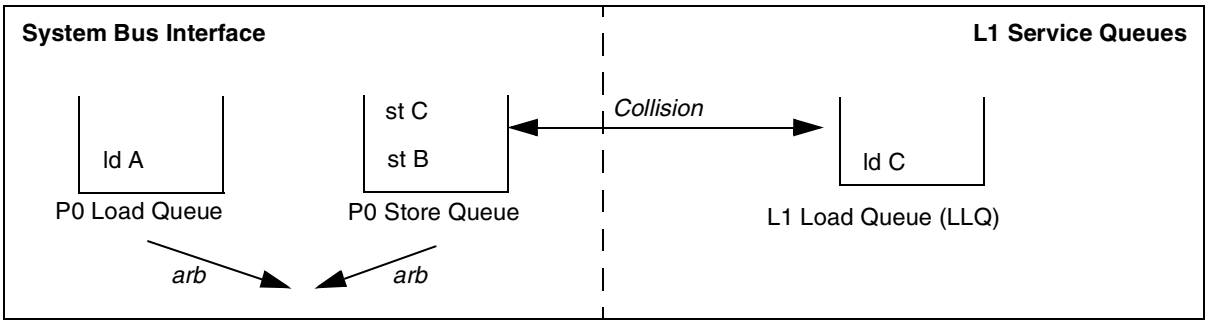
Figure 1. Example 1 with Condition 2

Example 1: The processor may make a load request to address 'A,' which gets retried. As a result of one of the conditions stated above, the high priority mechanism within the processor engages, and the processor goes to the external bus with a store queue request to address 'B.' The system must be able to process the store queue request to 'B' (and potentially several other store queue operations as described for condition 2), because the store queue may not relinquish control until 'B' (and others) successfully completes its (their) address tenure(s). This is shown Figure 1, where condition 2 has caused the high priority mechanism to be engaged.

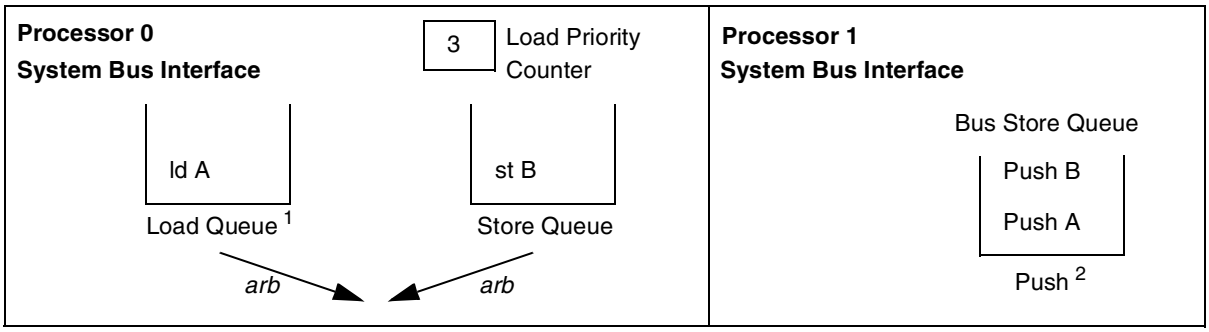
Figure 2. Example 2 with Condition 1

Example 2:In both 60x and MPX modes, the MPC7450 can cause push requests to the external bus, even if external intervention is enabled in MPX mode. In a multiprocessor system, a state can be entered where one processor (processor 0) has a load request to ‘A’ and a store request to ‘B,’ wherein the store request has gained high priority over the load request. A second processor (processor 1) has a push request queued for address ‘A’ followed by a push request to address ‘B.’ Processor 1 retries the store to ‘B,’ requests the window-of-opportunity, and attempts to push address ‘A.’ Although this is legal under the 60x/MPX specification, the MPC7450 is the first PowerPC processor to attempt this. As a result, some system controllers, including the Tundra Tsi106™ PowerPC host bridge or the Tundra Tsi107™ PowerPC host bridge, retry the push to ‘A’ because it requires a push to ‘B,’ since this is the address for which the window-of-opportunity was taken. A system that would not allow the push to ‘A’ to complete, would hang. This is shown in Figure 2, where condition 1 has caused the high priority mechanism to be engaged.

1 The load queue is an 11-entry queue in the system bus interface.
2 The push queue shares resources in the bus store queue with the castout queue, such that a combined total of ten pushes and castouts can be queued.
